# **Inspection Report**

Permit Number:	C0150007		
Inspection Type:	TECHNICAL		
Inspection Date:	Tuesday, April 03, 2007		
Start Date/Time:	4/3/2007 1:30:00 PM		
End Date/Time:	4/3/2007 6:30:00 PM		
Last Inspection:	Thursday, March 22, 2007

Site: HIDDEN VALLEY MINE

The Permittee is collecting baseline soil information from the Hidden Valley site for preparation of the Mining and Reclamation Plan for the proposed activation of the reclaimed A and B seam portals. Robert Long, Soil Consultanting, was evaluating the soils along the access road and proposed location for the storage/loadout facility on the plateau above the existing reclaimed site.

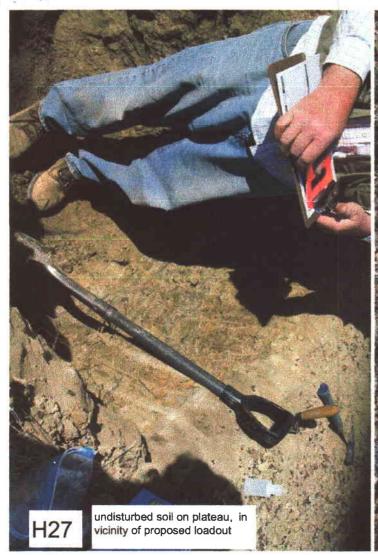
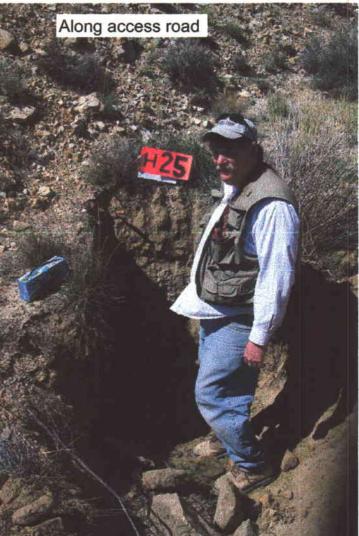
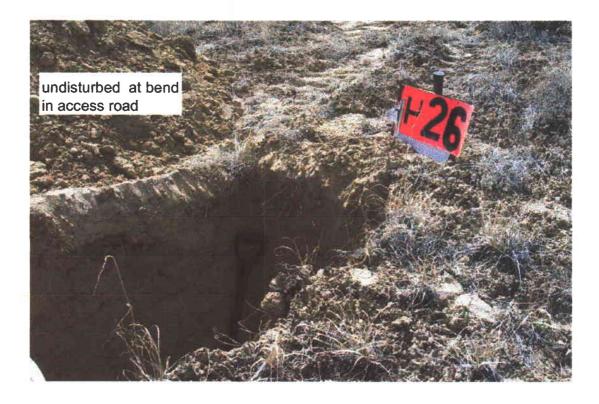
Prior to my arrival, a pit on the A seam slope had been evaluated. No coal mine waste was encountered at the location of the pit. Several trenches along the access road were evaluated for their potential to provide substitute topsoil. I observed and photographed the last two pits on the access road, and an undisturbed soil pit in the bend in the access road, and one pit in undisturbed soil on the plateau above the mine site. I walked to the area that is proposed for the surge pile. Mr. Long was going to return the next day to auger the soils in this surge pile area. They appeared to be shallow to sandstone and windswept. They were inaccessible to the backhoe. From my observations, there is approximately 6 - 12 inches of soil that could be salvaged from the access road. I have sent a copy of the "Reclamation Materials Assessment" prepared for Consol by Dr. Lewis Munk as part of the 1997 reclamation amendment to the MRP.
